LIMITED MEASUREMENTS OF STATIC LONGITUDINAL STABILITY IN
FLIGHT OF DOUGLAS D-558-1 AIRPLANE

(BUAERO NO. 37971)

Walter C. Williams

RESEARCH MEMORANDUM

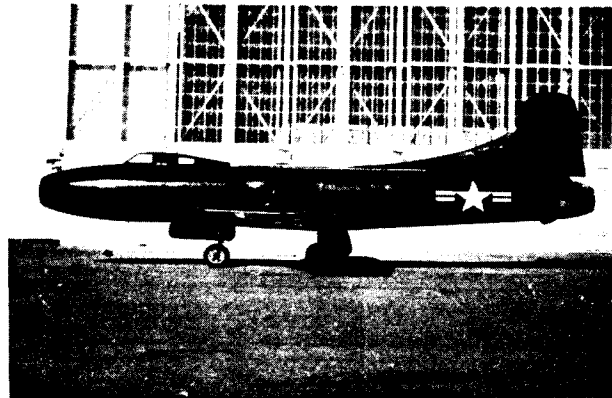
(a) Side view.

Figure 1.- Photographs of D-558-1 airplane.

The Douglas D-558-1 airplane is a single-place low-wing monoplane powered by a single General Electric TG-180 turbojet engine. General views of the airplane are given in figures 1(a), (b), and (c). A three-view layout of the airplane is given in figure 2. For the data presented herein the center of gravity was located at 25.7 percent mean aerodynamic chord and the gross weight was 10,258 pounds at take-off. Detail specifications of the airplane are given in table I.
